Australian Transport Safety Bureau

Examination of a Supair Strike Paraglider Harness Strap

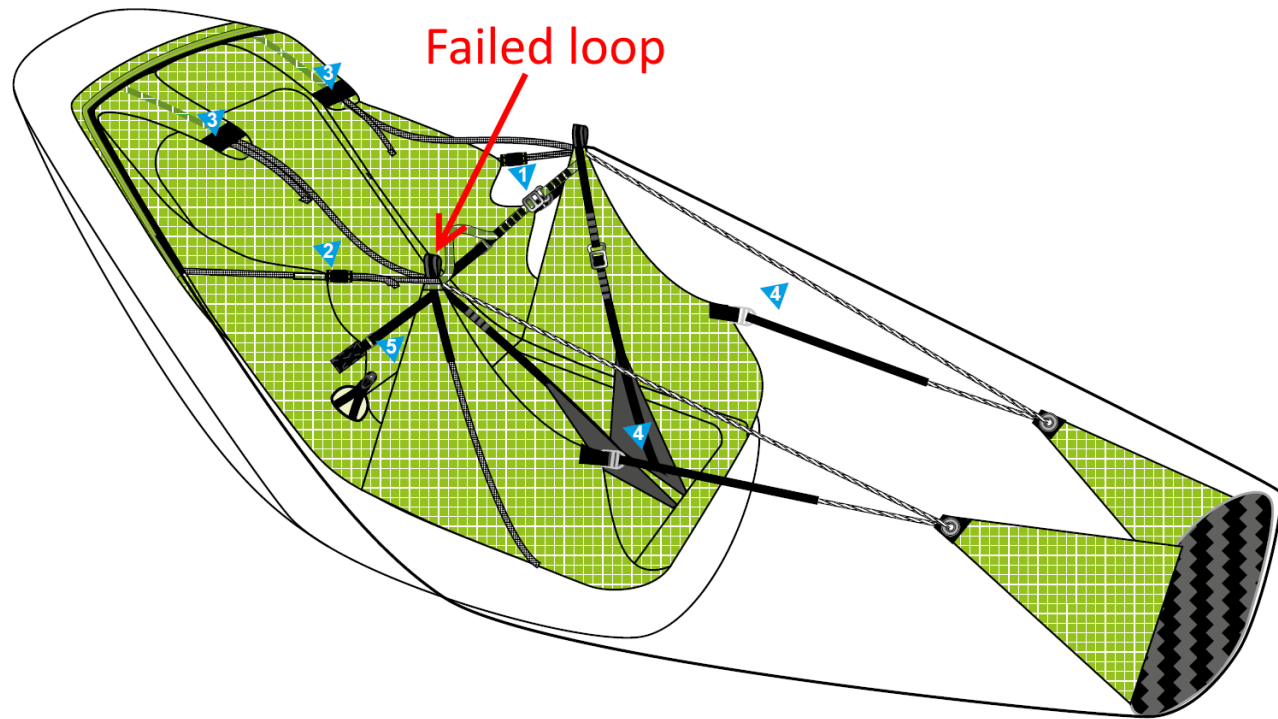
Failure Point

- The loop that failed was a Dyneema strap (ultra-high molecular weight polyethylene)
- A fabric sheath covered the strap to prevent wear

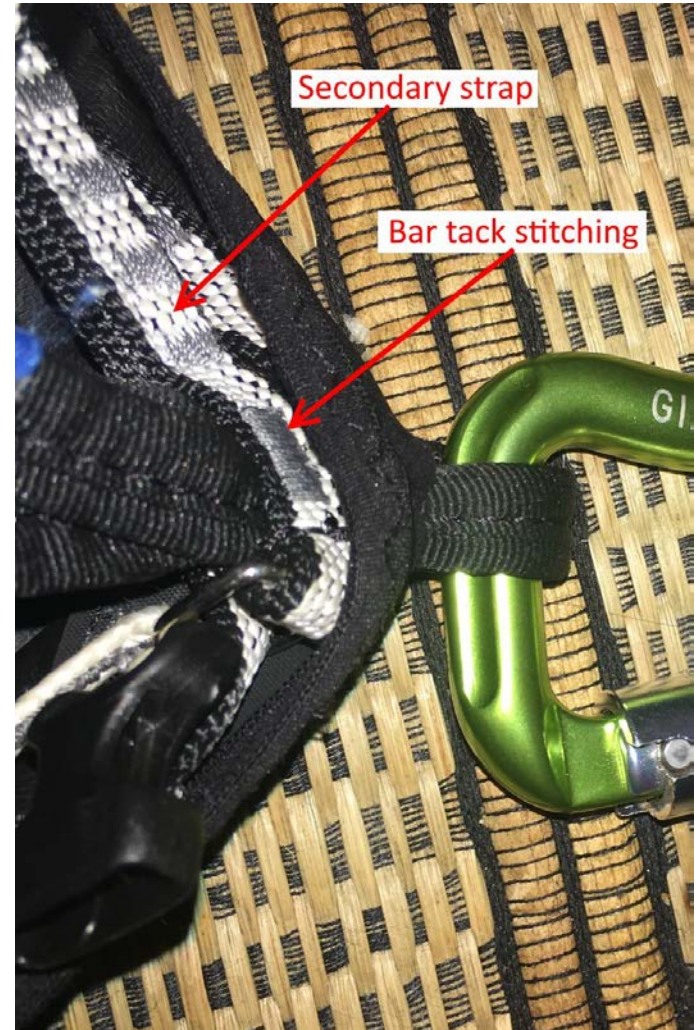
Left side comparison

- The left main hooking point had an identical construction to the failed right side.
- A secondary strap from the shoulder harness looped around the carabiner loop.
- Both loops, i.e. four layers of Dyneema from two different straps, were stitched together.

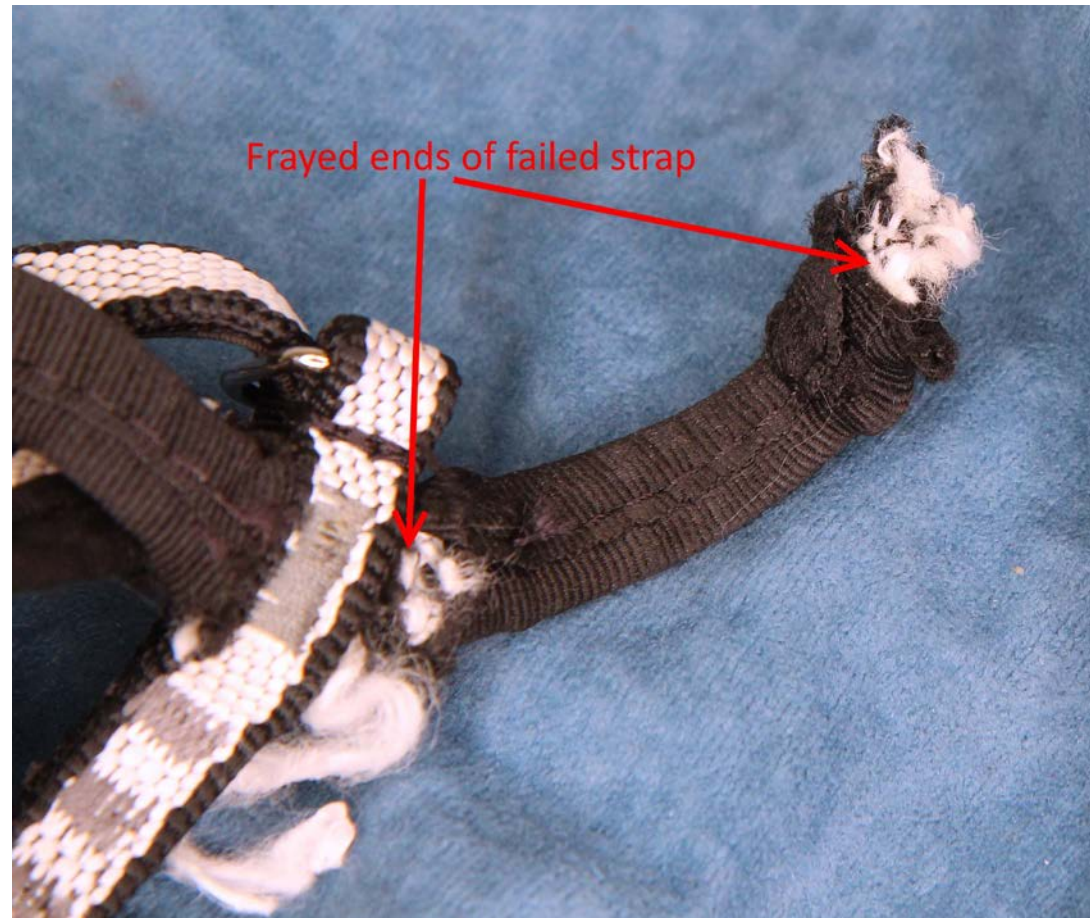
Failed strap examination (right side)

- The stitching was unpicked and the secondary strap removed, as well as the sheath around the carabiner loop
- The ruptured ends of the strap were examined under an optical microscope

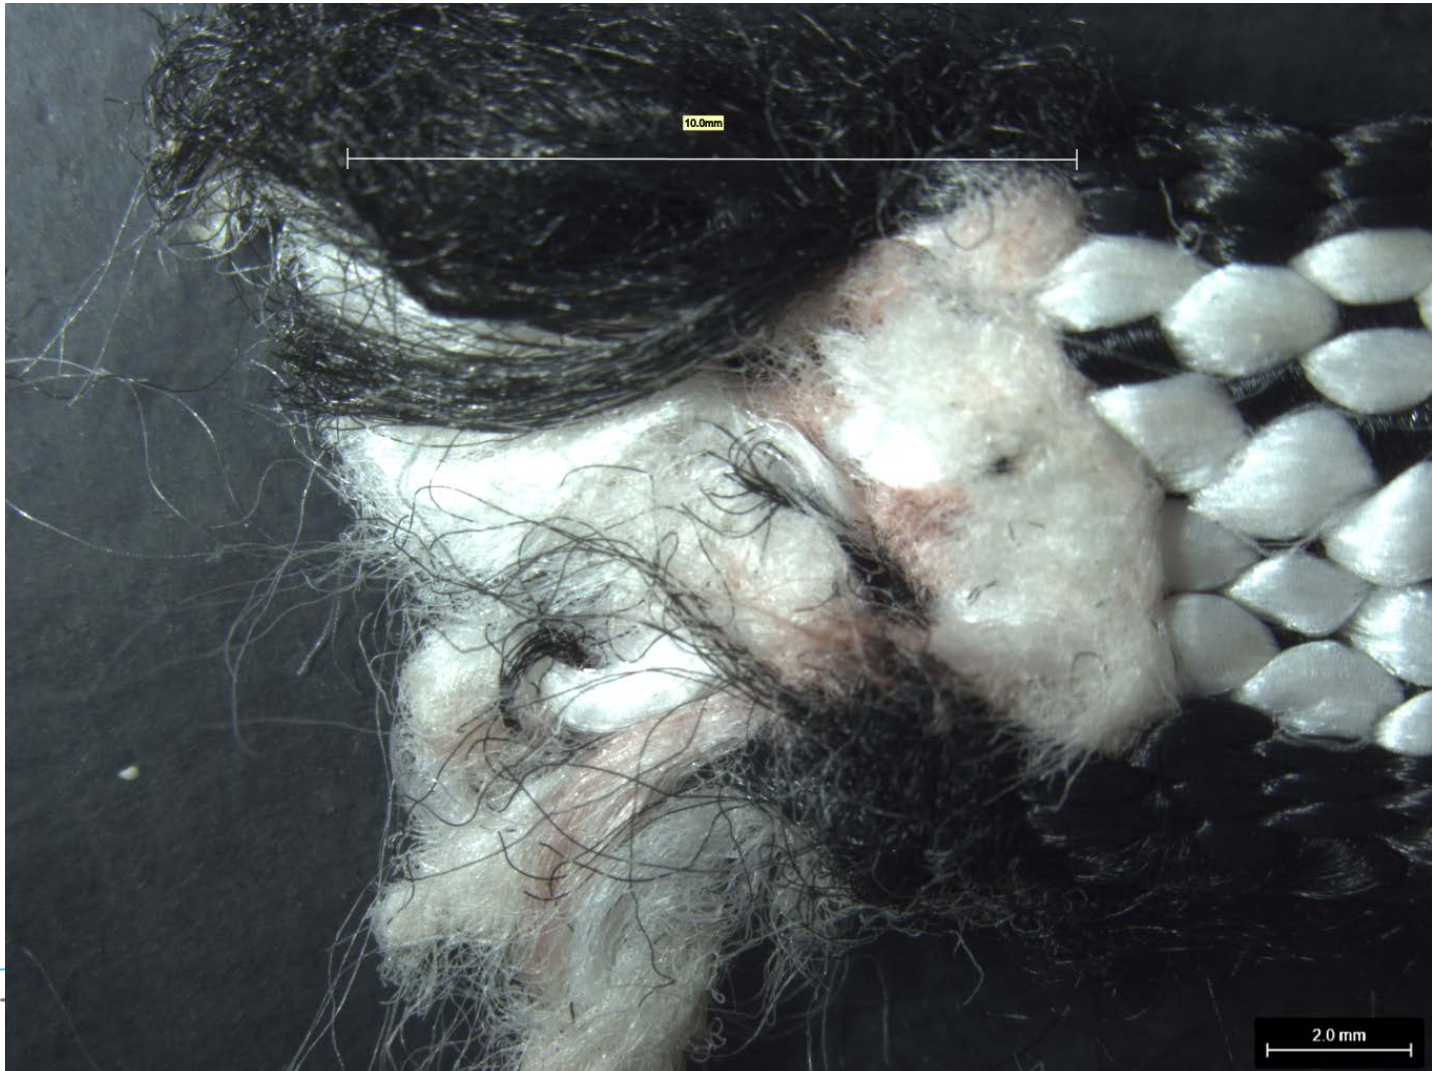
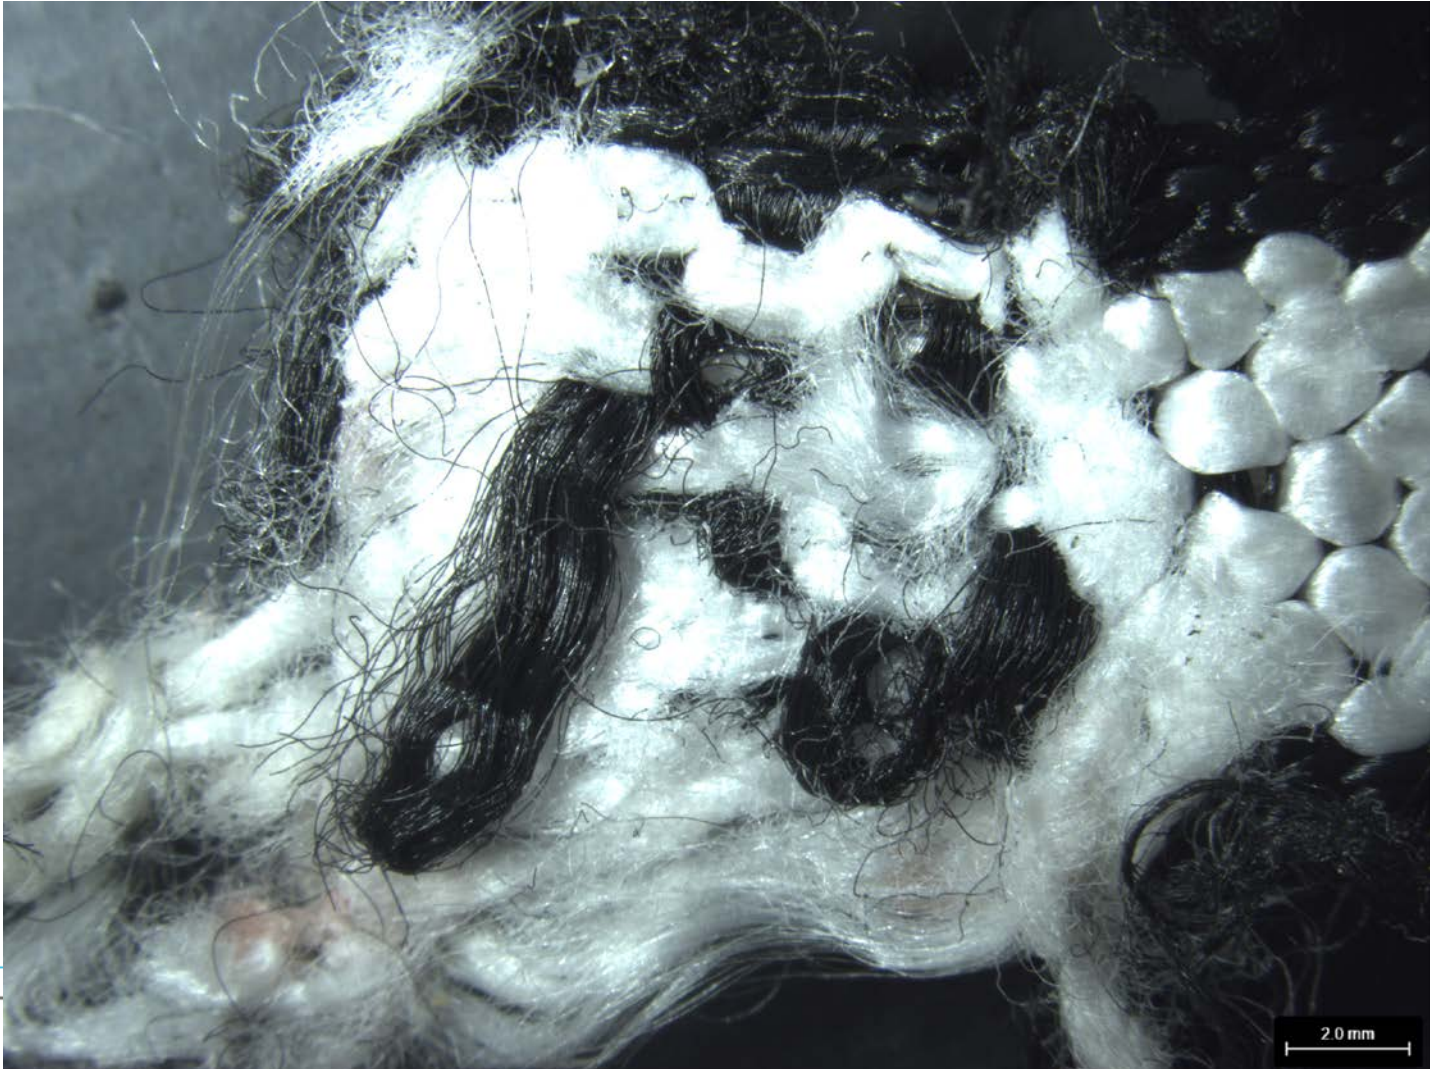
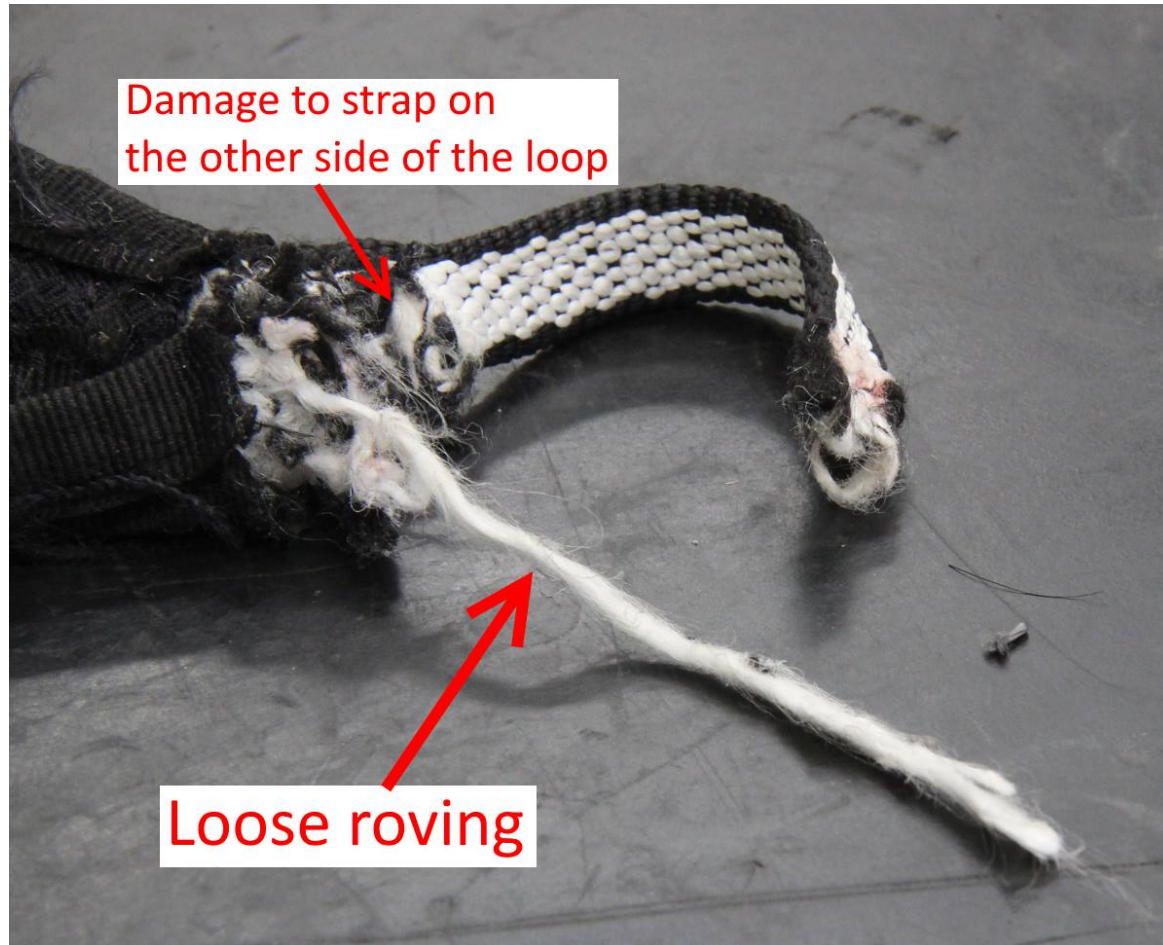
- Most of the strap filaments ruptured across a width of approximately 10-12 mm.
- The area of rupture coincides with the position of the secondary strap.
- Damage was present on the other end of the loop, where it also connected to the secondary strap. However, the strap had not entirely ruptured here.
- A single roving ruptured away from the primary point of failure. Its failure point was not identified .
 - Based on the length of the roving, it is likely on the other side of the loop; near the other point of contact with the secondary strap.
- Broomstraw effect is present at the point of rupture and the in the damage at the other end of the loop.

- The broomstraw effect at the point of failure and at the nearby damaged area indicate the strap failed in tensile overstress. The rupture and partial rupture occurred at points where a secondary strap was attached via stitching.

- Given that the areas of rupture coincided with the secondary strap, and given the damage from stitching observed on the unbroken left side of the harness, it is likely that the attachment of the secondary strap contributed to the strap failure.

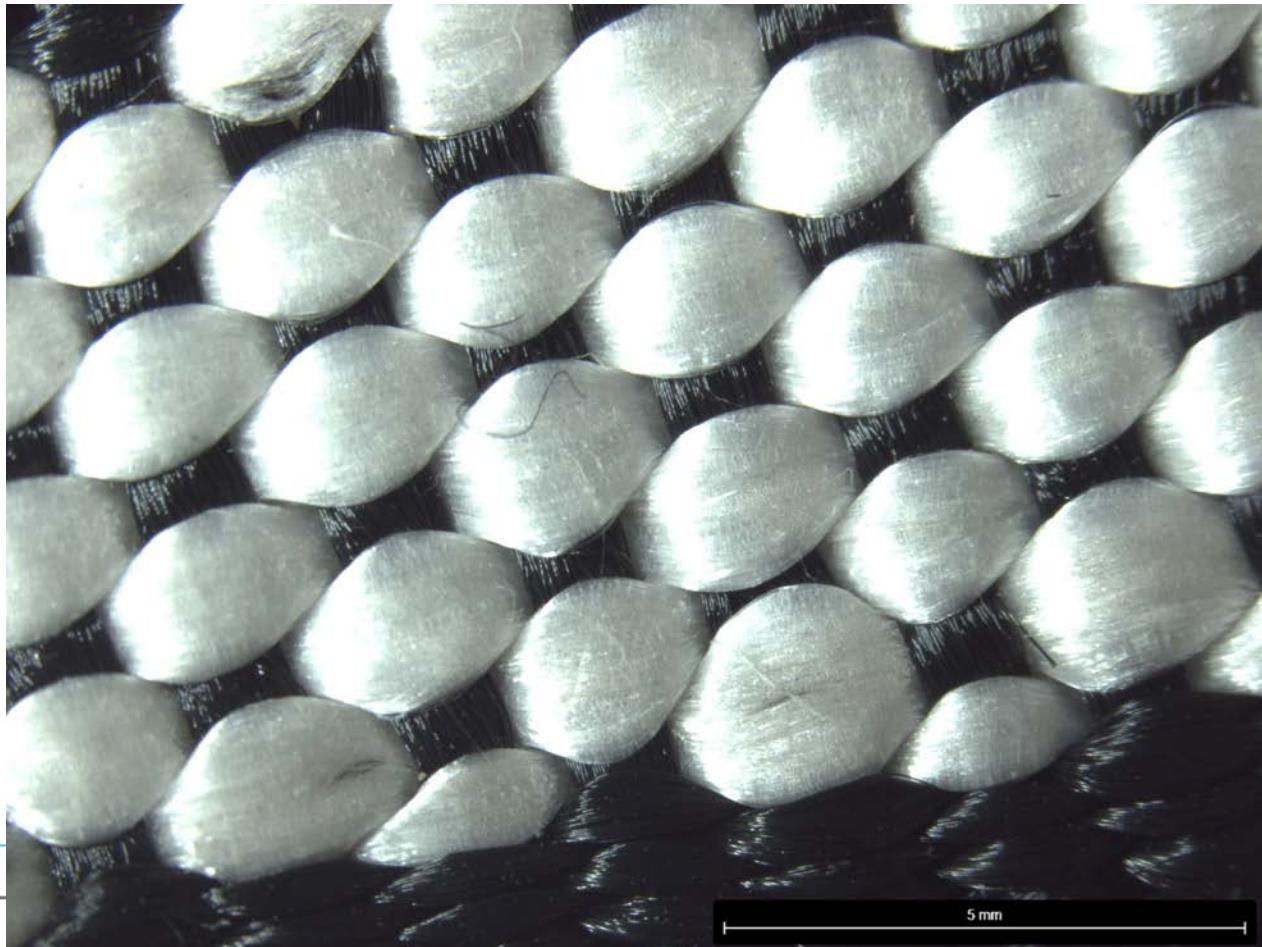
Left side examination

Image shows a section of Dyneema strap from the left side of the harness, where no other straps or attachments have been stitched.

- Warp and weft are well aligned
- A few broken filaments visible

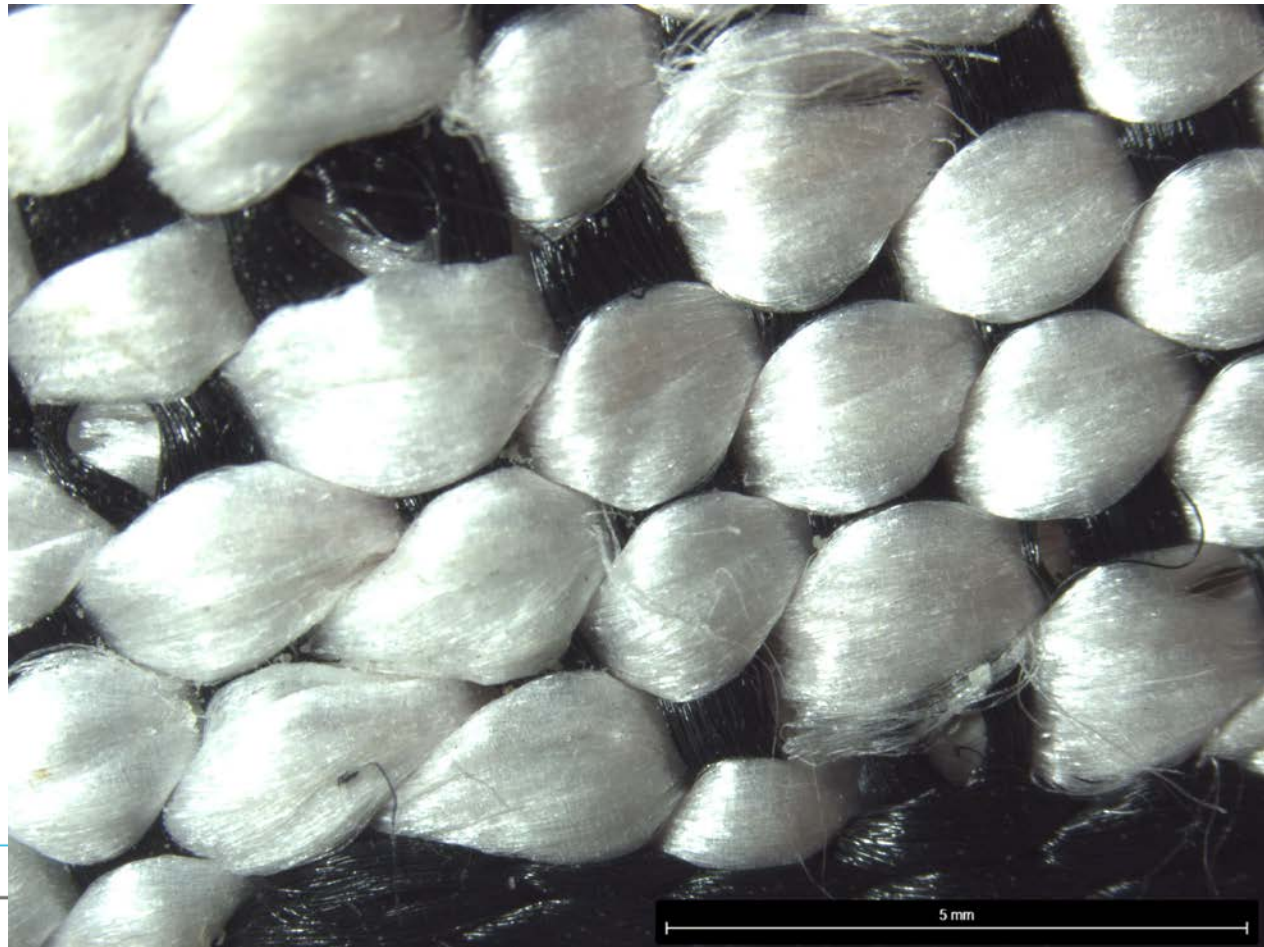
Left side examination

Image shows a section of Dyneema strap from the left side of the harness, where the secondary strap had been attached via stitching.

- Some deformation of warp and weft rovings
- More broken filaments than in the unstitched region
